NPIC/CSD 558/65  
4 NOVEMBER 1965  
PAGE 4

ROUTE 12  
MU GIA PASS AREA, LAOS

NATIONAL PHOTOGRAPHIC INTERPRETATION CENTER

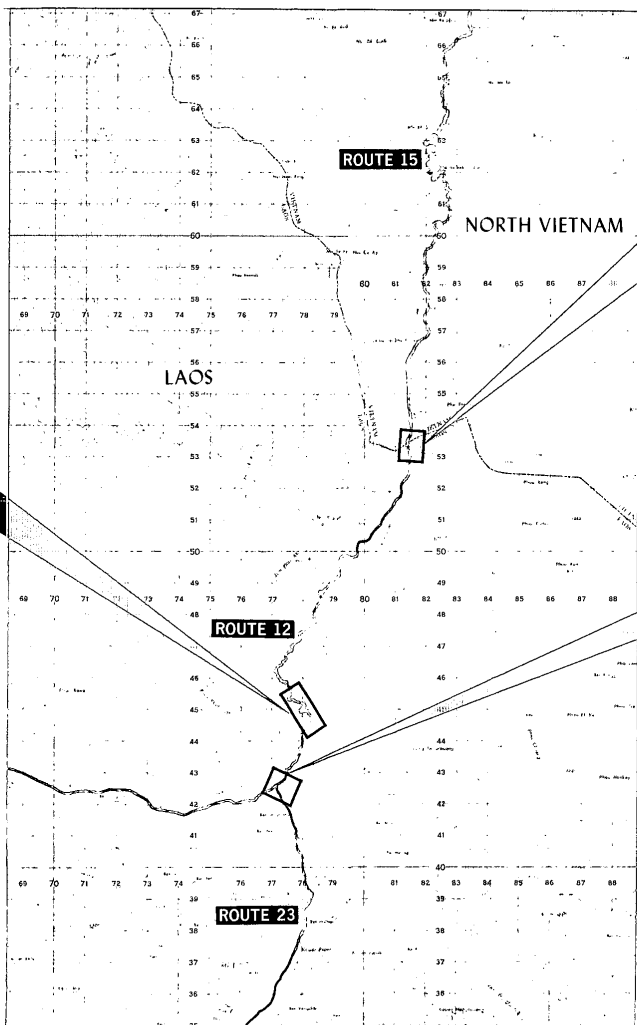
### ROUTE 12 MU GIA PASS AREA, LAOS

3. [REDACTED] REVEALS ROUTE 12 IN THE MU GIA PASS AREA TO BE SERVICEABLE FOR VEHICLE TRAFFIC FROM THE MU GIA PASS ARMY BARRACKS AND SUPPLY POINT [REDACTED] AT 1740N 10546E TO THE JUNCTION OF LAOTIAN ROUTES 12 AND 23 AT 1734N 10543E. THE MU GIA PASS CHOKE POINT, LOCATED 4.9 NM SOUTH-SOUTHWEST OF THE BORDER AT 1735N 10544E, HAS UNDERGONE EXTENSIVE REPAIRS TO THE AREAS OF INTERDICTION. ALL INTERDICTION POINTS HAVE BEEN FILLED OR BY-PASSED AND VEHICLE TRACKS ARE NOTED THROUGHOUT THE IMAGED PORTION OF ROUTE 12. ALL BUILDINGS AT THE MU GIA PASS ARMY BARRACKS AND SUPPLY POINT HAVE BEEN DAMAGED OR DESTROYED.
